**Flood Control Project Maintenance  
Levee Inspections**  
**LMA District Cover Sheet**  
**Spring 2019 Levee Inspection Results**

**Reclamation District No. 2103 Wheatland Vicinity**

**Spring 2019 Levee Inspection Results**

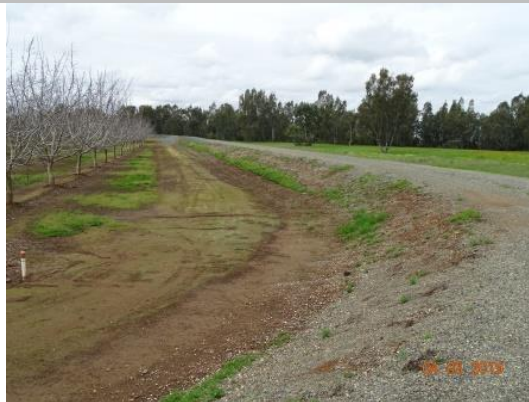
Photo 1 of 1 : SP\_2019\_RD2103\_10\_19\_20190409\_00042.jpg

View looking downstream landside at the well maintained annual vegetation, Spring 2019.

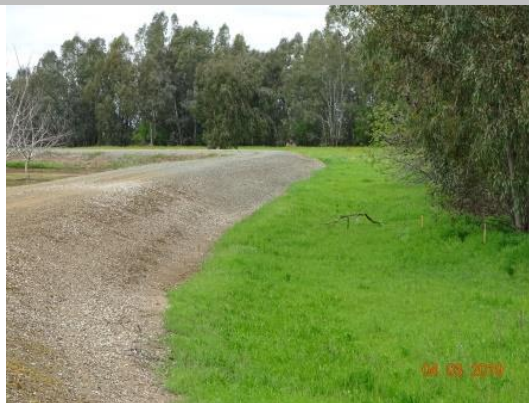
Photo 1 of 1 : SP\_2019\_RD2103\_10\_20\_20190409\_00041.jpg

View looking downstream waterside at the well maintained annual vegetation, Spring 2019.

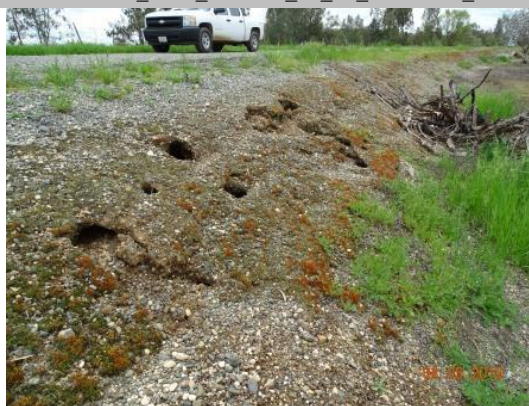
Photo 1 of 1 : SP\_2019\_RD2103\_10\_18\_20190409\_00040.jpg

View of squirrel holes on the landside looking downstream but no evidence of animal activity during Spring 2019 inspection.

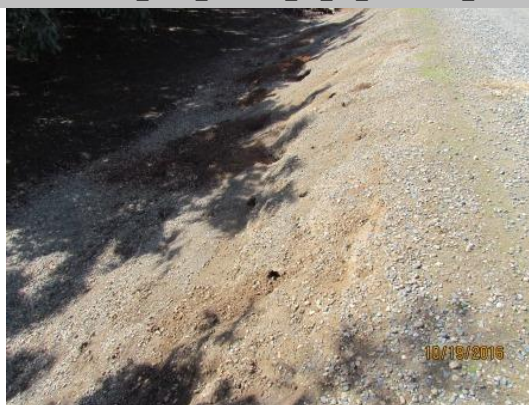
Photo 1 of 1 : SP\_2019\_RD2103\_10\_23\_20190305\_00003.jpg

LM Start	0.20	Rating **	M	Issue No.	23
LM End	0.22	Issue Type +	Ma	Location *	LS
Category	Earthen Levee			GPS Latitude/Longitude	
				Start	End
Item	Animal Control			39.020856 °	39.020938 °
				-121.450629 °	-121.450237 °
DWR ID	DWR_RD2103_01_f_2015_23				
Comment Code					
A3 : No rodents visible, but rodent burrows visible; need to backfill and compact or grout burrows.					
Inspector Comment					
Rodent holes in the levee slope need to be backfilled.

View of squirrel holes on the waterside looking downstream but no evidence of animal activity.

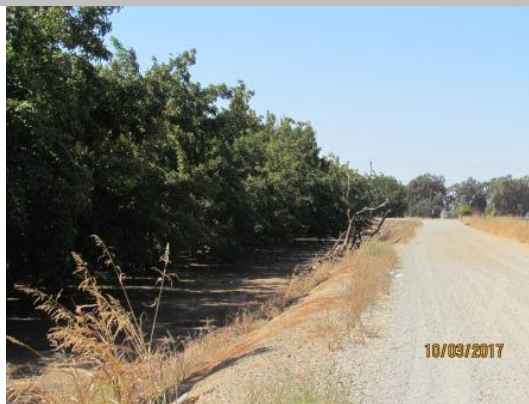
Photo 1 of 1 : SP\_2019\_RD2103\_10\_22\_20190305\_00002.jpg

LM Start	0.22	Rating **	M	Issue No.	22
LM End	0.22	Issue Type +	En	Location *	LS
Category	Earthen Levee			GPS Latitude/Longitude	
				Start	End
Item	Encroachments			39.020937 °	39.020937 °
				-121.450237 °	-121.450237 °
DWR ID	DWR_RD2103_01_f_2015_22				
Comment Code					
PR : Prunings					
Inspector Comment					
Prunings still exist and need to be removed.

View looking downstream landside of prunings that still exist.

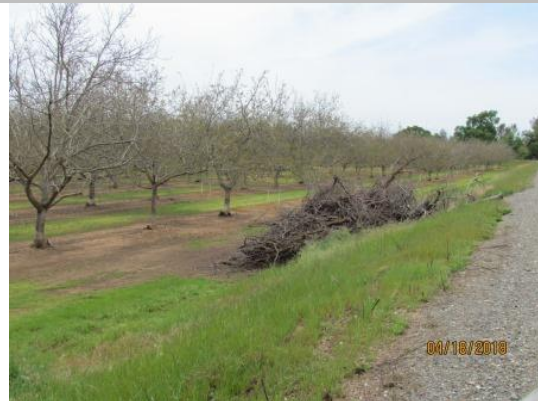
Photo 1 of 1 : SP\_2019\_RD2103\_10\_27\_20190305\_00005.jpg

LM Start	0.78	Rating **	M	Issue No.	27
LM End	0.78	Issue Type +	En	Location *	LS
Category	Earthen Levee			GPS Latitude/Longitude	
				Start	End
Item	Encroachments			39.024546 °	39.024546 °
				-121.441396 °	-121.441396 °
DWR ID	DWR_RD2103_01_s_2017_27				
Comment Code					
PR : Prunings					
Inspector Comment					
Prunings are located on the landside levee slope, Fall 2018.

View looking downstream landside of prunings on the levee slope.

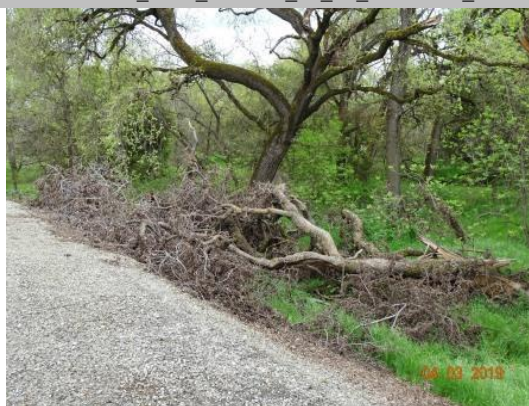
Photo 1 of 1 : SP\_2019\_RD2103\_11\_14\_20190409\_00034.jpg

View looking upstream waterside at a downed tree on the levee slope, Spring 2019.

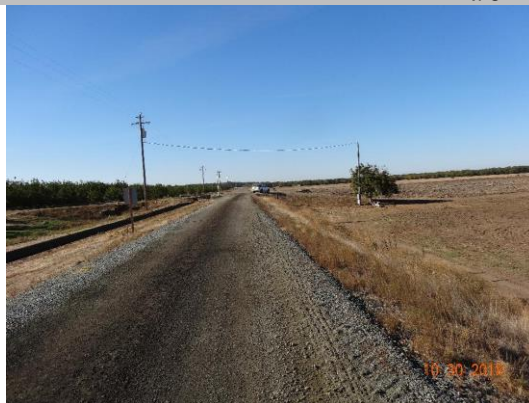
Photo 1 of 2 : UCIP\_SP\_2019\_53438\_78444.jpg

Overview of levee where crossing should be. No signs of crossing present.

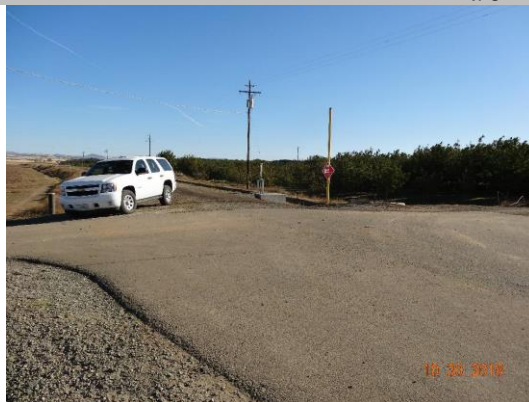
Photo 2 of 2 : UCIP\_SP\_2019\_53438\_78445.jpg

No signs of crossing are visible at approximate location.
